REPAIR & REPLACEMENT RESERVE REPORT

DORAL HOMEOWNERS ASSOCIATION

**606 Pebble Beach Drive
Silver Spring, Maryland 20904**

Project #306090

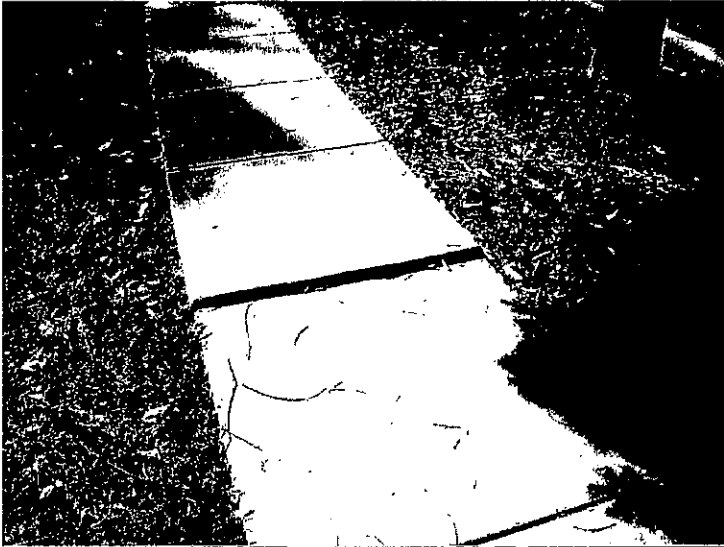
Photo #2: Across Hawkesbury Lane from 719, the sidewalk is out of alignment in several areas by some 2" causing a trip hazard. It is advised to shave down or replace the areas that are out of alignment. (Public Sidewalk)

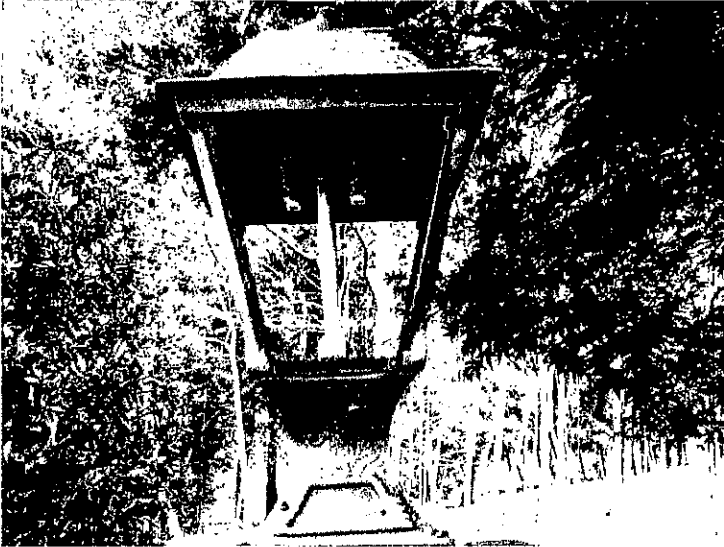
Photo #3: The entrance monument gas lights do not appear to be operational on either side. It is advised to refurbish them and place them into operation. In case the association has decided not to keep these operational, it is advised to remove the damaged lights, or to replace the damaged glass. Vandalized items that are not dealt with, give an invitation for more vandalism.

6. Entrance Monument Lamps	The entrance monuments have gas lamps which are no longer in operation. The estimated amount is for the replacement of these lamps with lamps of equal quality.

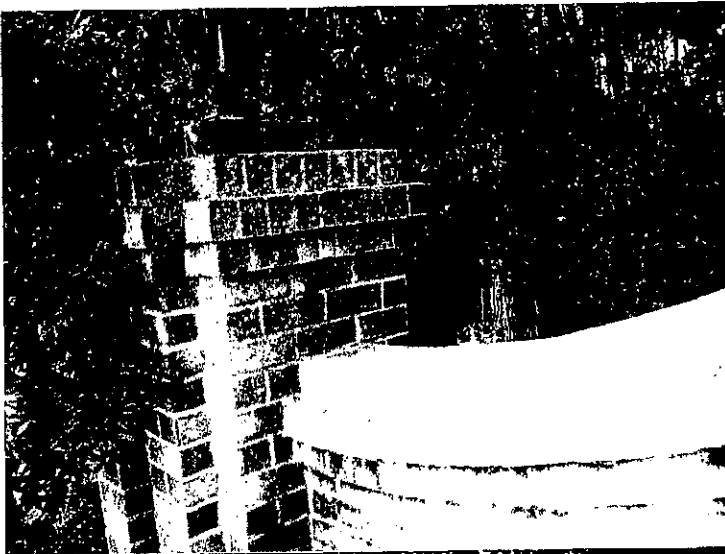
Photo #4: There is vegetation growing very near the monument brickwork. This can damage the brick by abrasion in wind and by retention of moisture. There is Leichen growing on the brick also. It is advised to clean the brick and trim back vegetation before these cause premature degradation to the wall.

Item Number	Description
4. Entrance Monument Brick	Brickwork of the entrance monument should never require full replacement if properly maintained. The estimated replacement cost is for the repair and reconstruction of the wall during the remaining life. Repairs would include reconstruction and repointing of approximately 65% of the wall.

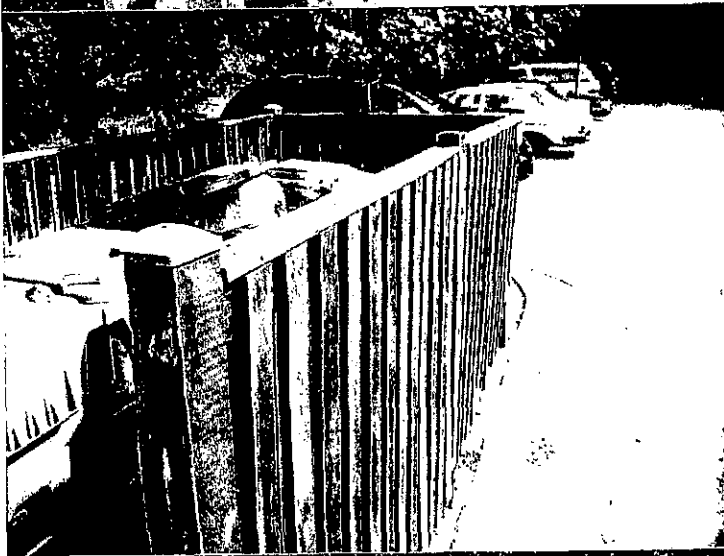
Photo #5: The paint on the wood garbage area surround has failed on the most exposed sections. It is advised to consider repainting the wall to protect the wood and extend its useful life.

3. Wood Fence	<p>The estimated replacement cost for the fencing around the trash collection areas for the townhouses, is based on the replacement of the existing wood fencing system with a new fencing system of equal style and quality.</p>
